Corrosion tests in water of fuel elements irradiated in the world's first NPP reactor^{*}

Citation: Ivanov SN, Porollo SI, Baranaev YD, Timofeev VF, Kharizomenov YV (2019) Corrosion tests in water of fuel elements irradiated in the world's first NPP reactor. Nuclear Energy and Technology 5(4): 337–343. <https://doi.org/10.3897/nucet.5.48427>

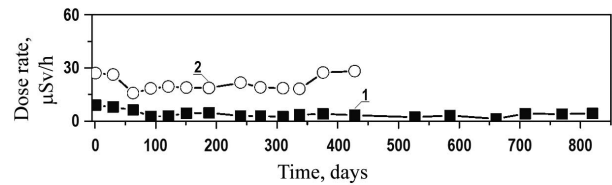
Figure 1. Change in the γ -dose rate of the water in the glasses with the FE fragments based on the U-Mo + Mg composition depending on the test time: 1. Sealed Fragment 1; 2. Fragment 2 with a through defect.

tion after 90 days of exposure was established at approximately the same level of $3.3 \pm 1.3 \mu\text{Sv/h}$ (Fig. 1). During periodic inspections of Fragment 1, no damage to its outer cladding was found. The γ -dose rate of the water from the glass with failed FE Fragment 2 with the U-Mo+Mg composition after a small drop at the beginning of the tests gradually increased from 16 to 28 $\mu\text{Sv/h}$ due to the release of radioactive fission products from the fuel via the through defect in the cladding. The water activity level after 430 days of testing in the glass with failed Fragment 2 was approximately nine times higher as compared to the average water activity level in the glass with sealed Fragment 1.

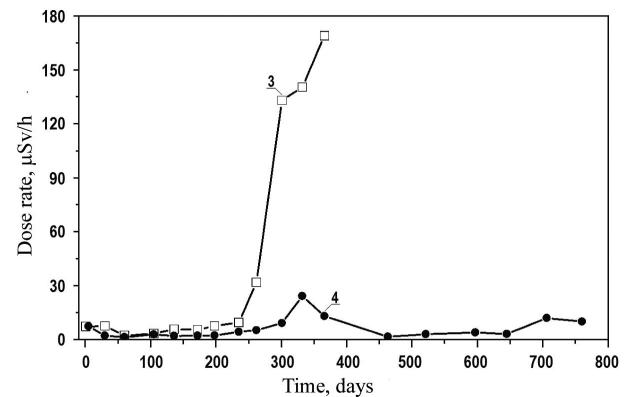
Figure 2. Change in the γ -dose rate of the water in the glasses with the FE fragments based on the UO₂+Mg composition depending on the test time: 3. Fragment 3 with a through defect; 4. Sealed Fragment 4.

The results of measuring the activity of the water samples from the glass with defect-free FE Fragment 4 with uranium dioxide fuel showed that during most of the tests the γ -dose rate varied from 1.4 to 12 $\mu\text{Sv/h}$ (Fig. 2). A short-term increase in the dose rate to 24 $\mu\text{Sv/h}$ on the 330th day of the test was most likely due to contamination of the selected water samples (due to insufficiently thorough washing of the tube after taking water samples from the glass with failed Fragment 3). The dose rate of

After an artificial defect was applied to FE Fragment 3 with UO_2+Mg fuel (60 days after the start of the test), an increase in the water activity was observed: initially it was slow (the gamma dose rate in the first 175 days of defect-water contact increased from 2.2 to $9.6 \mu\text{Sv/h}$), and then it became fast (over the next 130 days of fuel-water contact, the dose rate increased to $171 \mu\text{Sv/h}$). At the end of the tests, the water activity in the glass with the failed FE fragment with UO_2+Mg fuel increased 78 times.

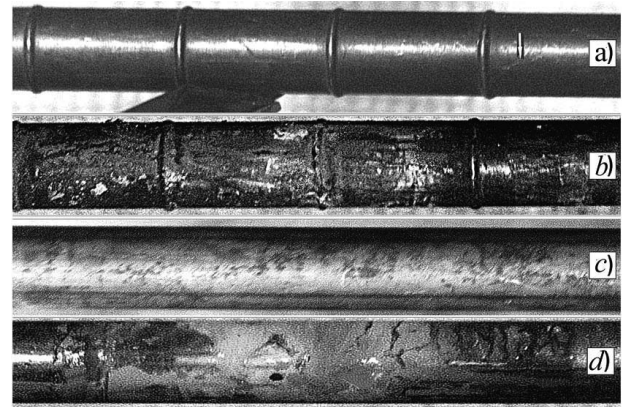
In the areas of the FE fragments located near and at the water-air interface in the glasses for corrosion testing (in the zone of the water level change), the largest number of various deposits formed. Deposits of black, white and light gray were observed on the surface of all the FE fragments in these areas, and a yellow or yellow-brown (rus-

Figure 3. View of the outer surface of the fuel elements: a) Fragment 1 (U-Mo+Mg composition) before the corrosion tests in water; b) Fragment 1 (U-Mo+Mg composition) after the corrosion tests in water for 820 days; c) Fragment 4 (UO_2+Mg composition) before to the corrosion tests; d) Fragment 4 (UO_2+Mg composition) after the corrosion tests in water for 760 days.

ty) deposit was also found on the surface of Fragments 1 (U-Mo+Mg) and 4 (UO_2+Mg). The surface appearance of the FE fragments, which was in the air during the corrosion tests, did not change.

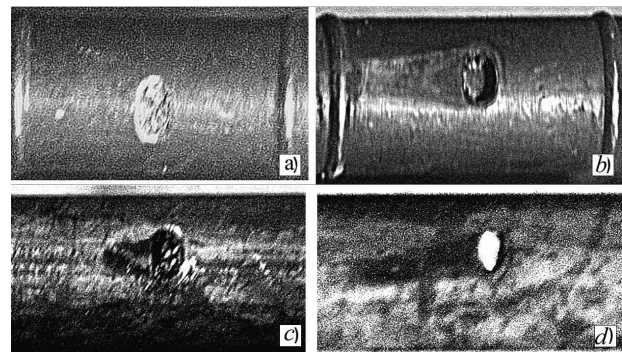
Figure 4. View of the outer surface of the FE fragments with an artificial defect after contact of the fuel composition with water: a) Fragment 2 with the U-Mo+Mg composition after 30 days; b) Fragment 2 with the U-Mo+Mg composition after 165 days; c) Fragment 3 with the UO_2+Mg composition after 75 days; d) Fragment 3 with the UO_2+Mg composition after 170 days.

In Sample 2 with U-Mo+Mg fuel, in the artificial defect, only local surface oxidation of the fuel composition was observed (Fig. 4a); after 60 days, leaching of the fuel with the formation of a cavity was detected. After 135 days of testing, a light gray plaque formed on the surface of the cladding around the defect, and after 165 days of testing, the fuel composition of the artificial defect was leached out over the entire thickness of the fuel annulus, while the inner cladding was visible (Fig.4b). In the further tests up to 430 days, the appearance of the artificial defect in Fragment 2 did not change.

In the contact zone of the fuel composition (UO_2+Mg) with the water of FE Fragment 3, the surface of the artificial defect turned dark gray, and a black plaque formed on the surface of the cladding near the defect. After 75 days of contact of the fuel composition with water, a cavity was found at the defect site (Fig. 4c), and after 170 days, the entire surface of the defect turned white (Fig. 4d). In the further tests up to 305 days, the appearance of the defect in Fragment 3 did not change.

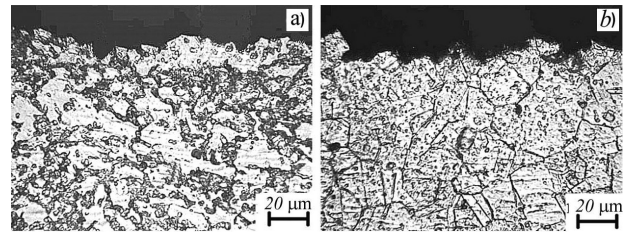
During the metallographic studies of the failed FE fragment with the U-Mo+Mg composition after the corrosion tests, we detected pittings, ulcers (10–20 μm deep) (Fig. 5a), intergranular corrosion (up to 15 μm deep) and areas with local frontal corrosion (up to 35 μm deep), while the maximum corrosion depth was observed in the area of the sample located in the water. The depth of corrosion damages on the outer side of the outer cladding before corrosion testing ranged from 5 to 20 μm . Thus, the corrosion tests for 430 days in the water led to the appearance of deeper (by 10–15 μm) corrosion defects, compared with the defects found on the cladding before the corrosion tests. The depth of corrosion ulcers on the inner side of the inner cladding reached 25 μm , which is comparable in magnitude with the corrosion defects on the FE cladding before the corrosion tests. The thicknesses of the outer and inner claddings during the corrosion tests did not change and amounted to 0.20–0.23 and 0.38–0.42 mm, respectively.

When examining the failed FE fragment based on dioxide (UO_2+Mg) fuel after the corrosion tests, we detected ulcers, pittings and areas with local frontal corrosion on the outer side of the FE outer cladding, while the depth of corrosion damages was mainly 2–17 μm (Fig. 5b) and only the depth of individual ulcers was 25–35 μm . The maximum depth of corrosion damages was also observed in the sample area located in the water. The depth of corrosion damages on the outer side of the outer cladding before corrosion testing ranged from 7 to 15 μm . The corrosion tests for 365 days in the water led to the appearance of only a few deeper (by 10–15 μm) corrosion defects, compared

Figure 5. Microstructure of the material on the outer side of the outer cladding of fuel elements with (a) U-Mo + Mg fuel and (b) UO_2+Mg fuel after irradiation, long-term storage, and corrosion tests in an aqueous medium for 430 and 365 days, respectively.

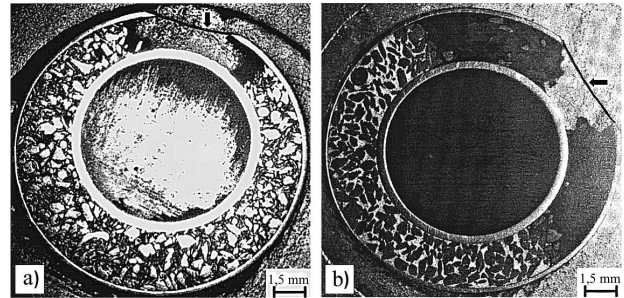
Figure 6. General cross-sectional view of the FE fragments with U-Mo+Mg fuel (a) and UO_2+Mg fuel (b) after testing in water for 430 and 365 days, respectively (arrows indicate the contour of the outer surface of the artificial defect prior to corrosion testing).

Figure 6 shows a general cross-sectional view of the FE fragments with fuel compositions based on U-Mo+Mg and UO_2+Mg dioxide at the location of the artificial defect. It can be seen that as a result of exposure to the water in both cases, the fuel composition was leached out via the through defect.

Planimetric measurements showed that in the cross-section of the FE fragment based on a U-Mo+Mg alloy in the defect zone, an area of 9 mm² (or 11% of the total area of the fuel kernel) of the fuel composition was leached out to form a cavity extending in the radial direction throughout the width of the annulus of the fuel element and in the angular direction, in a section with a length of 7.7 mm along its perimeter.

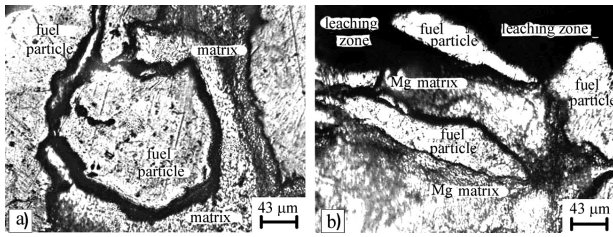
Figure 7. Microstructure of the fuel composition U-Mo+Mg in the cross-section of the artificial defect after testing the FE sample in the water for 430 days: away from the through defect (a) and in the zone of contact with the aqueous medium (b).

The irradiated fuel composition U-Mo+Mg, after long-term storage and corrosion tests of the FE fragments with the through defect outside the fuel leaching zone, remained intact, and no cracks were found in the fuel grains and magnesium matrix. As a rule, fuel grains are tightly adhered to the matrix, and dark belts with a width of up to $30 \mu\text{m}$ are observed around them (Fig. 7a). In the contact zone of the fuel composition with the water, the magnesium matrix was selectively dissolved, while the fuel grains did not dissolve (Fig. 7b). After the matrix was dissolved around the fuel grains, it was separated from the fuel composition and placed in the cavity, and then, falling into the water, sank to the bottom of the glass, in which the sample with the through defect was located.

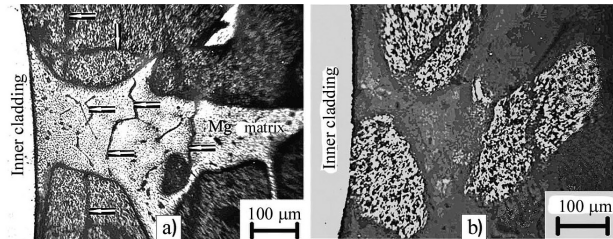
Figure 8. Microstructure of the fuel composition UO_2+Mg in the cross-section of the artificial defect after testing the FE sample in the water for 365 days: away from the through defect (a) and in the zone of corrosion interaction with the aqueous medium (b).

The irradiated fuel composition UO_2+Mg after long-term storage and corrosion tests of the FE fragments from the section, where the artificial defect was located, consisted of two parts (Fig. 8).

The first part of the fuel composition, located far from the through defect, was not exposed to the corrosive effects of the water and retained the structure characteristic of irradiated fuel of this type after long-term storage – in the magnesium matrix (light gray, Fig. 8a) and in the fuel particles (dark gray color, Fig. 8a) numerous microcracks were found (shown by arrows), voids were observed around many fuel grains.

The other part of the fuel composition adjacent to the through defect underwent severe corrosion (oxidation) and consisted of a dark gray matrix and a few fuel particles that did not crumble during the manufacture of the microsection (Fig. 8b).
