Examination of fuel elements irradiated in the reactor of the World's First NPP after long-term storage*

Abstract

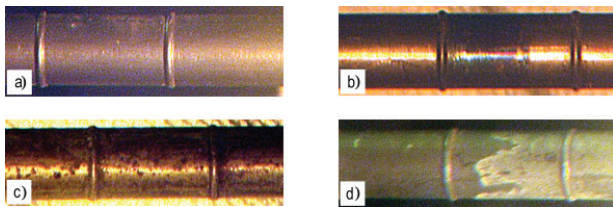
Figures 1 and 2 show the most characteristic areas of the outer surface of the examined fuel elements. The inspection showed neither visible damage to the outer

claddings of the fuel elements nor defects in the form of cracks, pits, pittings and other corrosion damage. Nor were there local swellings found on the outer claddings, indicating the presence of through destruction in a given place. The surface of all the fuel elements with U-Mo fuel was covered with a thin film of light gray color, on which one could see scrapes, scratches, traces of abrasion and scoring as well as spots of tarnish colors (Fig. 1a, b). There were spots with films and deposits of gray, brown and white color on the surface of many fuel elements (Fig. 1c, d) and of rust color on some fuel elements. Most of the surface of 45 of the 50 examined fuel elements with UO₂ fuel is covered with a thin layer of gray or dark gray color (Fig. 2a, b), the surface of other fuel elements is light silvery (Fig. 2d). On the surface of all the fuel elements, one could find scrapes, scratches, traces of abrasion, scoring and tarnishing as well as spots with films and deposits of white, gray, light brown and black color (Fig. 2b, c, d).

Figure 1. Typical view of the outer surface of the spent fuel elements with U-Mo+Mg fuel from the AM reactor after long-term dry storage for 45–55 years: **a)** gray surface; **b)** area with tarnish colors; **c)** multiple spots of brown plaque; **d)** area with a white film.

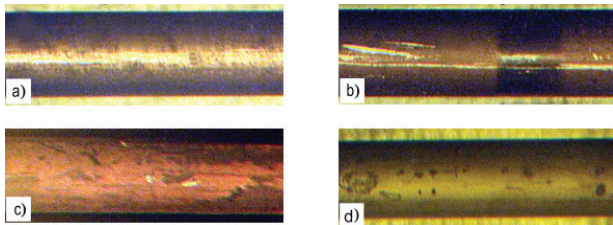
Figure 2. Typical view of the outer surface of the spent fuel elements with UO₂+Mg fuel from the AM reactor after long-term dry storage for 15–22 years: **a)** gray surface with dark gray plaque spots; **b)** dark gray surface with scrapes and scratches; **c)** surface with brown and white deposits; **d)** light silvery surface with gray plaque spots.

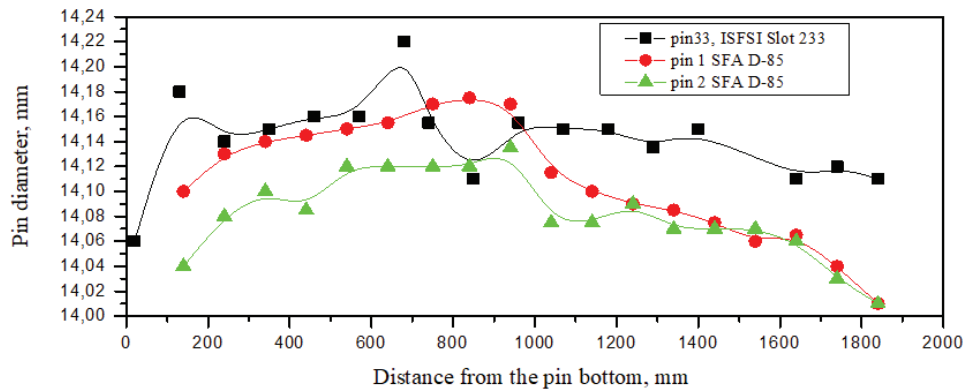
The results of measuring the diameter of fuel element 33 with U-Mo fuel are shown in Fig. 3. Also shown for

comparison are the results of measuring the diameters of two D-85 fuel elements immediately after irradiation. It can be seen that the diameter of fuel element 33 is larger than the diameters of the other two fuel elements. This difference is especially noticeable in the upper parts of the fuel elements.

Figure 3. Changes in the diameters along the length of fuel element 33 after long-term storage and D-85 fuel elements immediately after irradiation with U-Mo fuel.

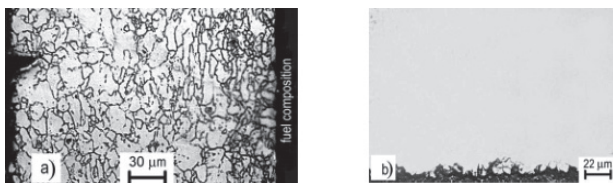
Figure 5. A wedge-shaped pit on the outer side of the outer cladding (a) and intergranular corrosion with grain chipping on the inner side of the inner cladding (b) of irradiated fuel element 33 with U-Mo fuel (in a section of 400 mm from the bottom of the fuel element) after storage for 45–55 years.

On the outer side of the outer cladding (on the side of the cladding contact with the gaseous medium of the reactor during irradiation) of fuel element 33, intergranular corrosion up to 9 μm deep, pittings 4–5 μm deep, and rounded or wedge-shaped pits 10–20 μm deep are observed (Fig. 5a). On the inner side of the cladding (on the side of contact with the fuel), there are only pits 1–3 μm deep to be observed (Fig. 5a).

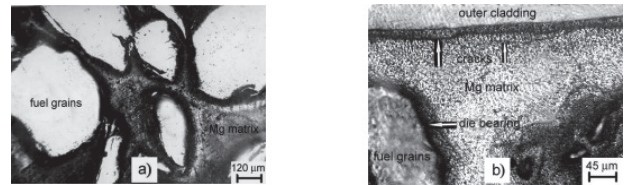
In fuel element 33, the fuel composition consisting of U-Mo alloy particles in a magnesium matrix retained its integrity. The fuel grains were tightly linked to the matrix, and around the fuel grains in the matrix, dark gray belts 25–35 μm wide were observed (Fig. 6). Tight adhesion is maintained between the magnesium matrix and the claddings, but single microcracks were found in the magnesium matrix near the claddings (Fig. 6b).

Figure 6. (a) Microstructure of the U-Mo fuel and (b) contact zone of the fuel composition with the cladding of fuel element 33.

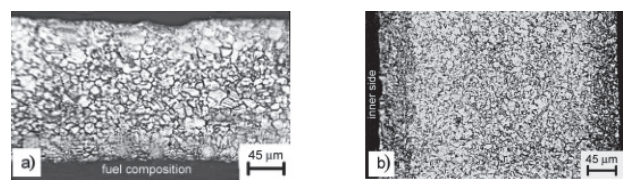
Figure 7. Microstructure of the material of the outer (a) and inner (b) cladding of fuel element 38 with $\text{UO}_2 + \text{Mg}$ fuel after irradiation and storage for 15–22 years.

On the outer side of the outer cladding of fuel elements 8 and 38, after storage for 15–22 years, in the lower, middle and upper parts, separate areas with corrosion defects in the form of uneven frontal corrosion, pits and pitting were found, the depth of which was 6–15 μm (Fig. 7a). On the inner side of the outer cladding (on the side of the cladding contact with the fuel), depressions 4–18 μm deep were observed.

element 8 had a light surface. Metallography showed that in the central part of the outer cladding of fuel element 38 with a dark gray surface in a section 100–120 μm wide, along the grain boundaries, numerous precipitates were found (Fig. 7a), while in the cladding material of fuel element 8 with a light surface there were no precipitates along the grain boundaries.

On the inner side of the inner cladding of fuel elements 8 and 38, in some areas of the perimeter, uneven frontal corrosion with a depth of 7–20 μm , pits and pittings up to 15 μm deep are observed (Fig. 7b). On the outer side of the inner cladding (from the side of contact with the fuel composition) of the fuel elements, in some areas of their perimeter, there were depressions with a length along the perimeter of 50–100 μm and a depth of up to 10 μm .

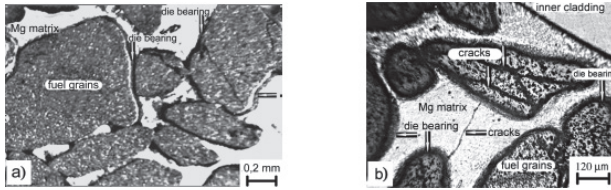
Figure 8. Microstructure of the material of the fuel composition of the irradiated fuel elements with UO_2 fuel: (a) before and (b) after long-term storage.

In the fuel composition of fuel elements 8 and 38 in the magnesium matrix around the fuel grains, dark gray belts 20–45 μm wide and microcracks in the fuel particles and the magnesium matrix were found (Fig. 8b). In the

fuel composition of the irradiated fuel elements examined immediately after irradiation, there were no microcracks and the thickness of the belts around the fuel particles was 10–30 μm (Fig. 8a).

The belts around the fuel particles in the matrix of the dispersive fuel elements were formed during irradiation in the reactor as a result of damage to the matrix material by fission products (Weber and Girsh 1956; Samoylov et al. 1969). The thickness of these belts could also increase during long-term storage as a result of further damage to the matrix by α -particles emitted from the fuel grains.
