# Soil erosion rates based on anatomical changes in exposed roots – case study from southwest Bulgaria

Eli Pavlova-Traykova, Dimitar P. Dimitrov

*Forest Research Institute, Bulgarian Academy of Sciences, 132, “St. Kliment Ohridski” Blvd.1756 Sofia, Bulgaria*

**Citation:** Pavlova-Traykova E., Dimitrov P.D. 2023. Soil erosion rates based on anatomical changes in exposed roots – case study from southwest Bulgaria. *Silva Balcanica* 24(3): 27-33. <https://doi.org/10.3897/silvabalcanica.24.e116223>

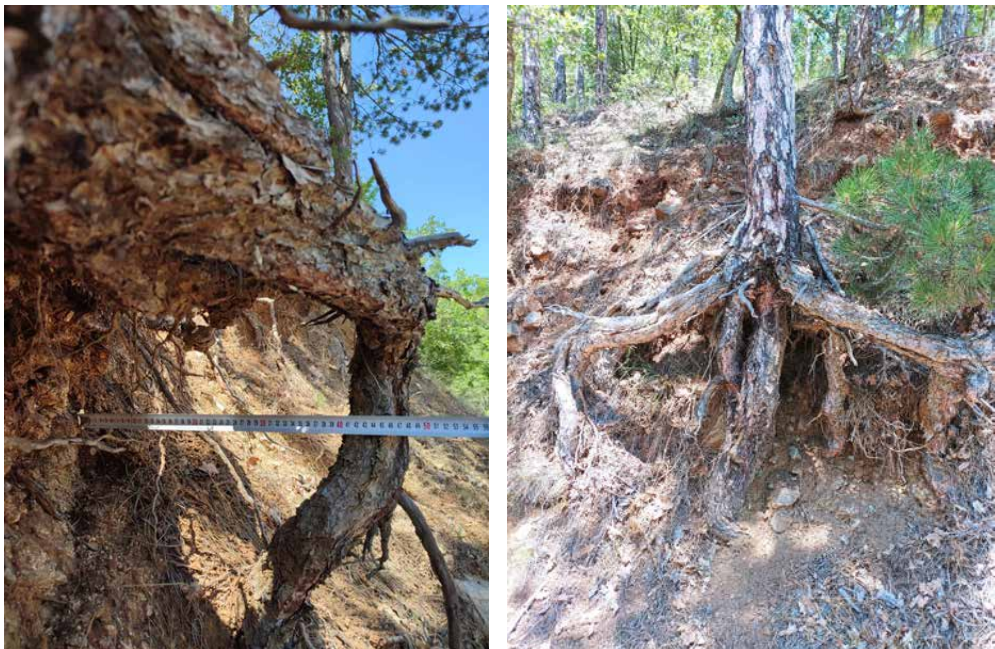
**Figure 1.** Morphology of eroded trees

Exposed tree roots from two tree species (*Pinus nigra* Arn. and *Pinus sylvestris* L.), growing on the gully sides were used as samples during 2022-2023 (Fig. 1). We used the approach for dating of individual erosion events likely caused by some triggering hydrometeorological event. A saw was used to cut two centimeters wide cross-sections (root discs) from the exposed roots. The position of each sample was carefully recorded and the distance from soil measured.
