Dismantling and decontamination of large-sized radiation-contaminated equipment during Research Building B decommissioning at the Bochvar Institute site*

The article presents the results of work on dismantling the large installation equipment of Research Building B at the Bochvar High-technology Research Institute of Inorganic Materials (Bochvar Institute). The works were carried out as part of Building B preparation for decommissioning. The purpose of dismantling the large-sized capacitive equipment was to reconstruct the large installation site for managing radioactive waste generated during Building B decommissioning. The works on decommissioning a radioactively contaminated building within a densely populated district of megalopolis were carried out for the first time.

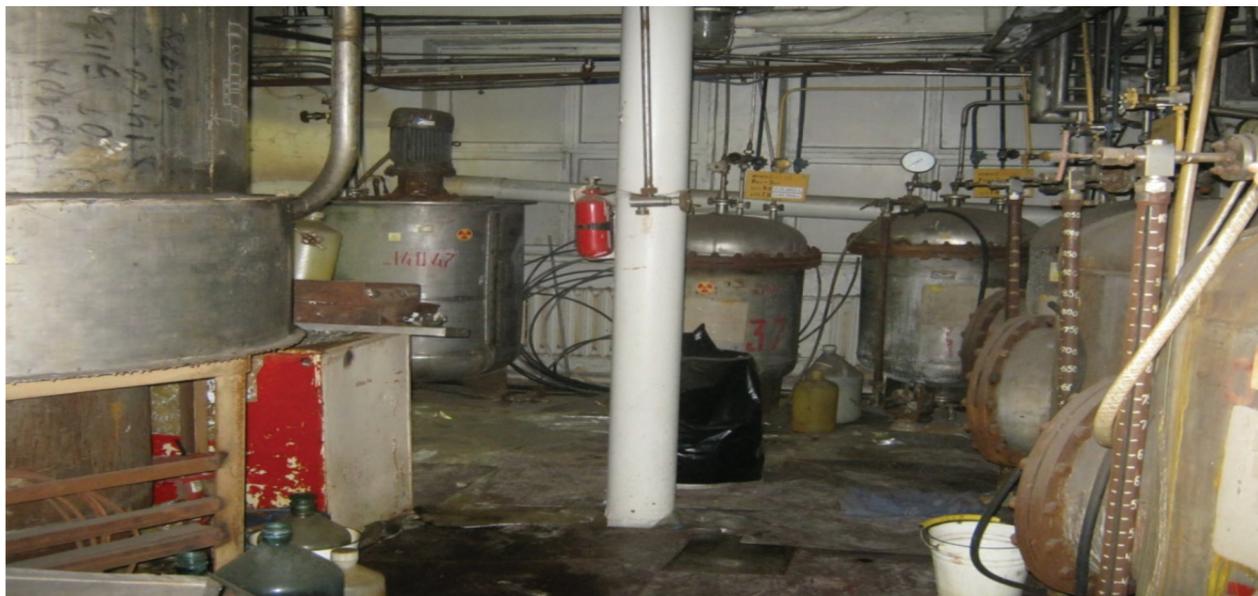
Figure 1. Radiochemical facility equipment.

The radiochemical facility had four decks. The floor of the lowermost deck was concrete and the floors of upper deck were made of corrugated metal sheeting. The facility area on the lowermost deck floor is 138.6 m². The entrance to the facility was from the second deck. The main equipment of the facility included tanks, pumps, pipelines, receivers, pulsators, electrical appliances, and instrumentation and automated control systems (Fig. 1). A list and brief characteristics of the capacitive equipment are given in Tab. 1.

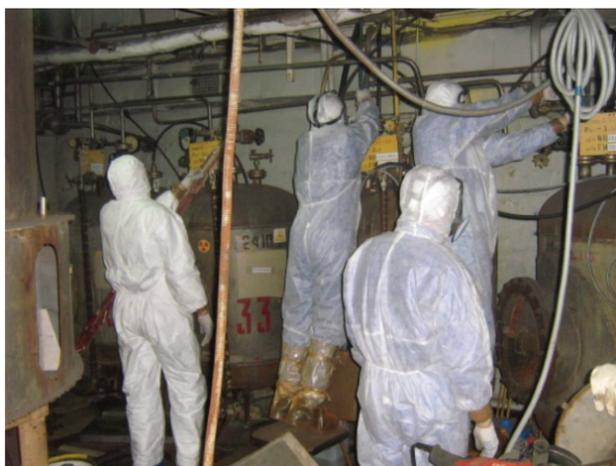
Figure 2. Dismantling the process pipelines.

taminated pipelines was about 1500 m (with pipe diameters from 12 to 120 mm). The pipes were made of stainless steel, rubber, plastic, and ferrous metal. The piping manifolds were removed both using a hydraulic tool and manually (the connector for mating flanges) (Fig. 2). The instrumentation of the monitoring, measuring and control systems was completely dismantled; the instrumentation and automated control cables were disconnected from the sensors and instruments of control, protection and alarm systems, and dismantled.

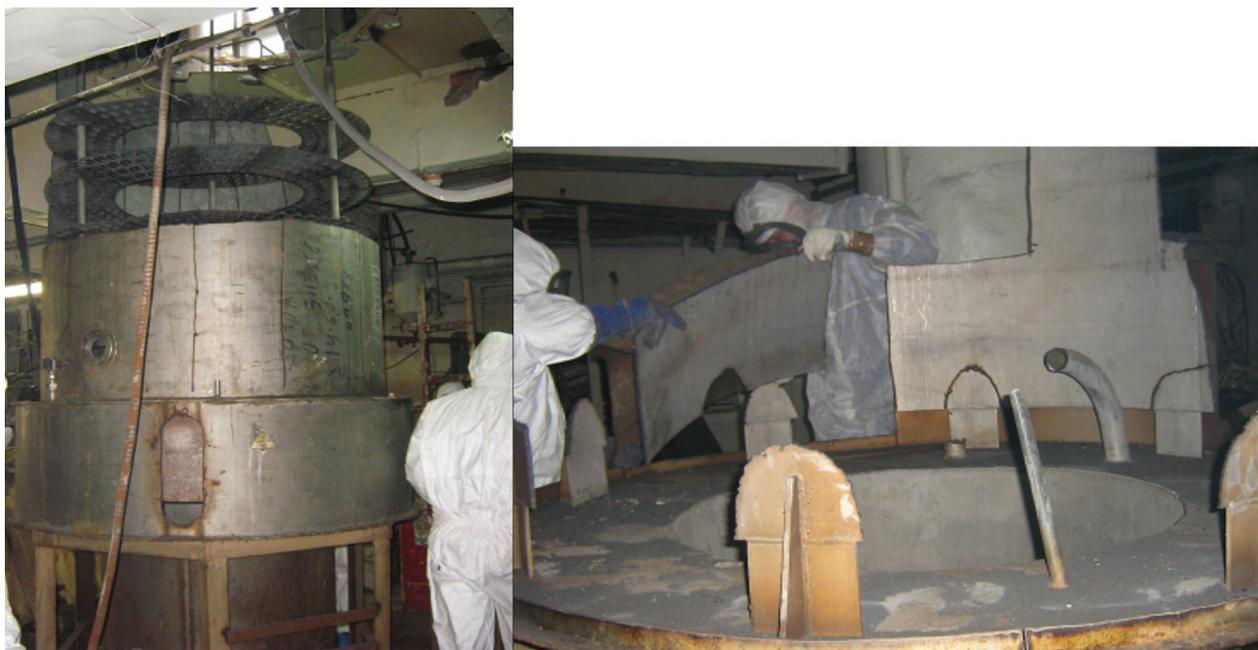
Figure 3. Removal of the column-type equipment.

To dismantle them in accordance with the design solutions, a monorail hoist was mounted and a winch was installed on the beam channels of the facility the uppermost deck. Hatches were cut into the upper deck floors and the columns were dismantled through these hatches (Fig. 3).

Dismantling was carried out using plasma cutters and a local suction to prevent radionuclides from entering the air of the working area.

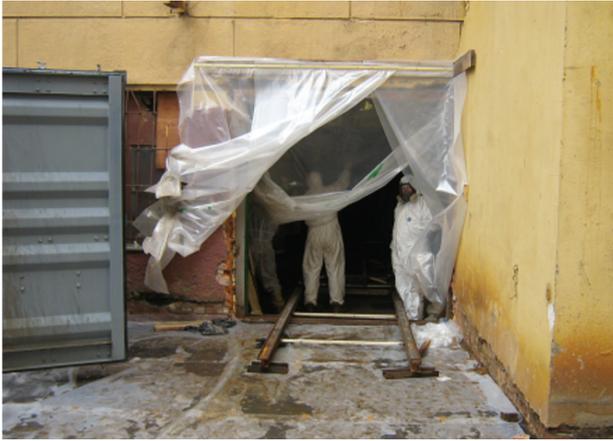
Figure 4. Opening in the wall of the radiochemical facility; crane runways.

In order to remove large-sized capacitive radioactive wastes from the large installation the lowermost deck, the window opening was expanded. The expanded opening was reinforced with welded metal structures. From the outside, the opening was sealed with two layers of

For the mechanized removal of the large-sized capacitive equipment, crane runways and guides were created and carts were used. The crane runways and guides were made in a mobile version to extend them beyond the building for at least one meter, to mechanize the movement of large-sized radioactive waste into the transport container (Fig. 4).

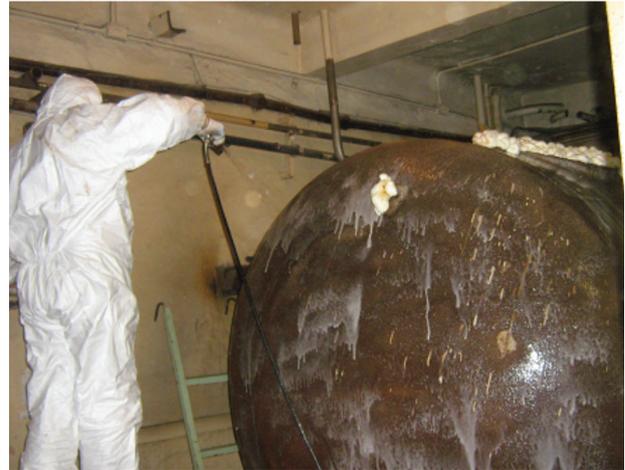
Figure 5. Applying polymer localizing coating.

During the dismantling process, all the holes in the equipment were filled with mounting foam. Polymer coating based on polyvinyl alcohol was applied on the equipment to be removed, to localize surface radioactive contamination. To create a more stable coating, it was applied twice: the second layer was applied after the first layer was completely dried (Fig. 5).

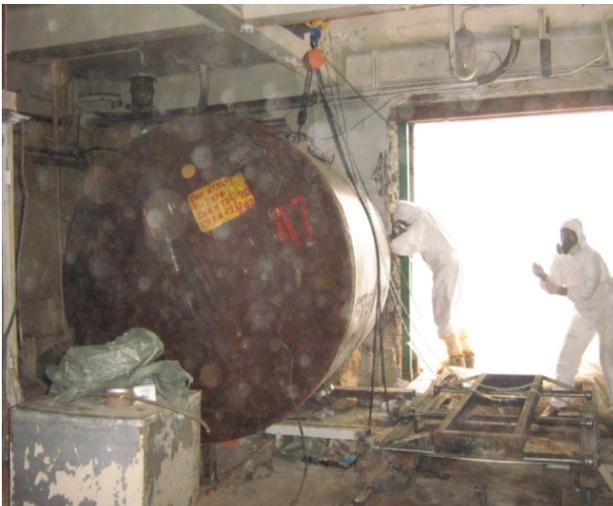
Figure 6. Dismantling and removal of the large-sized capacitive equipment.

The dismantled large-sized equipment was disconnected from the beds and stands; then, with the help of the hoist and the winch, it was moved onto a cart on the crane runways; afterwards it was fixed on the cart and moved into a transport container (Fig. 6).

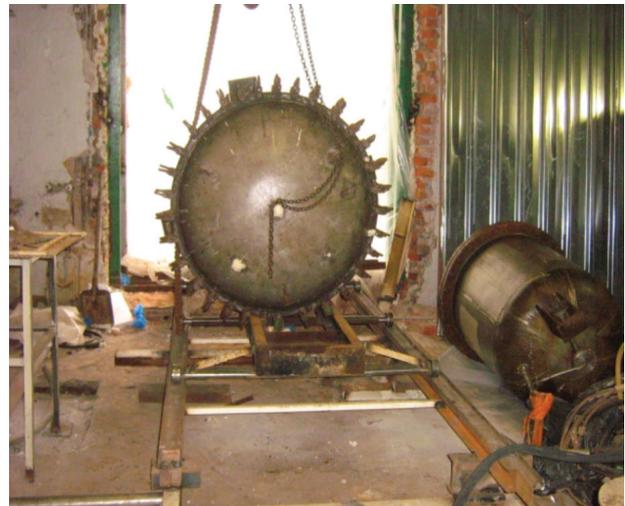
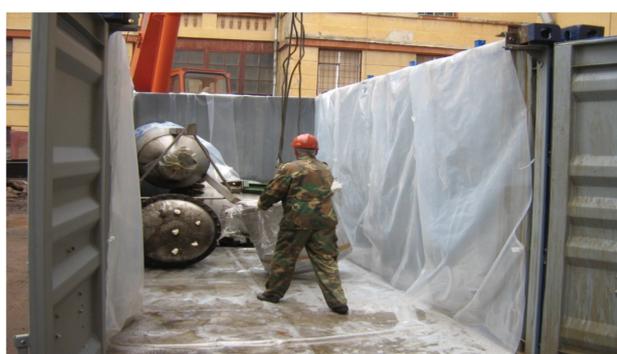
Figure 7. Loading of the large-sized radiation-contaminated equipment into the PU-2ETS-ST transport containers.

The large-sized process equipment was loaded into the PU-2ETS-ST containers (Fig. 7) and sent to FSUE RosRAO for compaction, conditioning and temporary storage before being transferred to the National Operator for RW and Technological Waste Management (Vereshchagin et al. 2017).

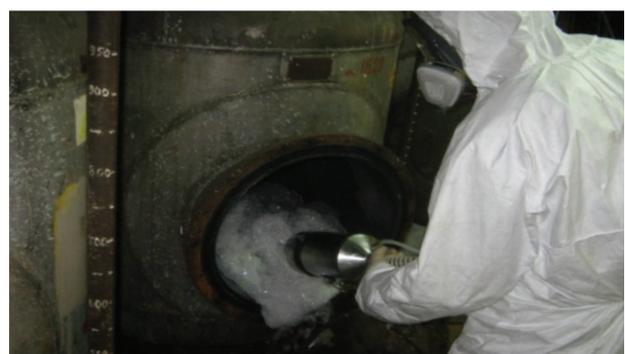
Figure 8. Foam decontamination of the internal equipment surfaces.

As mentioned above, it was not possible to completely decontaminate the internal equipment surfaces. Decontamination was carried out by treating the internal equipment surfaces with acidic foam compounds (Fig. 8). The decontamination factor ranged from 25 to 70. As a result

of the decontamination works, the radioactive waste activity was reduced (for radiation-determining transuranic radionuclides, the RW class was changed from 3 to 4) (Resolution of the Government of the Russian Federation No. 1069).
